# **TA1 Inspection**

Inspection Number 16055958 Customer No
Serial Number TDY12898 Customer Name

Make CATERPILLAR Customer Email

Model 315 Completed On 2/12/2024

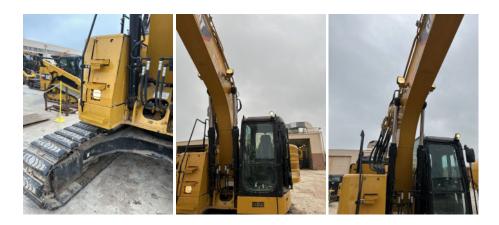
3.4 Work Lights

NORMAL
