1991 SKY TRAK 6000M TELEHANDLER

INSPECTION DETAILS

Inspection Type	[REDACTED]
Inspection Form	Standard
Inspection #	10143674
Inspection Status	Inspected
Created	08/22/24 14:43:04
Updated	08/23/24 07:00:00
Created By	[REDACTED]
Inspector	[REDACTED]
Salesperson	[REDACTED]
Serial #	M1A0660
SMU / Hours	2,016
Location	Rio Medina , TX, United States

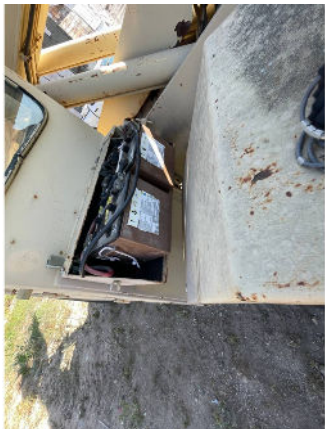
Crankcase Guard / Battery Box

cover missing

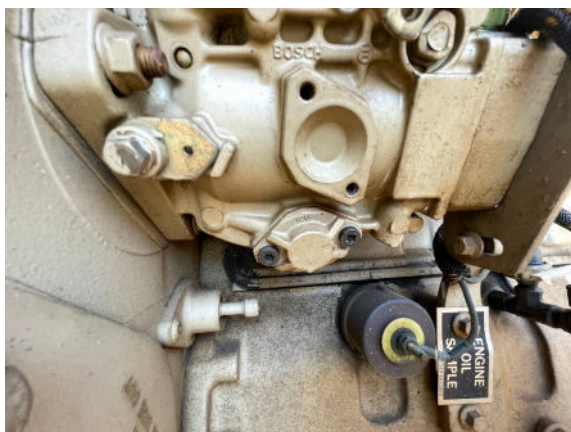
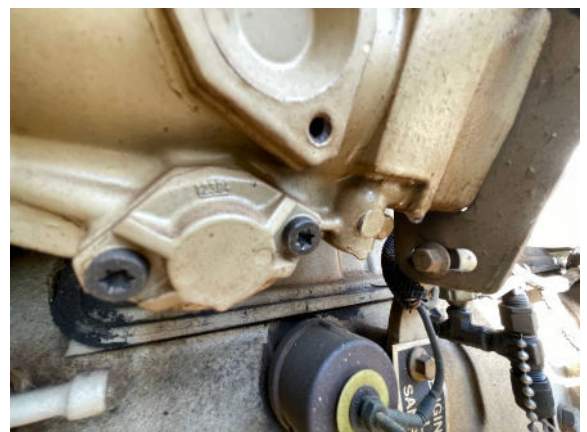
Fuel Injection System

Notes - ENGINE
engine smokes black smoke,
also fuel injection pump leaking
fuel

fuel pump on engine is leaking fuel between the front and back sections.

● main injection pump is leaking fuel

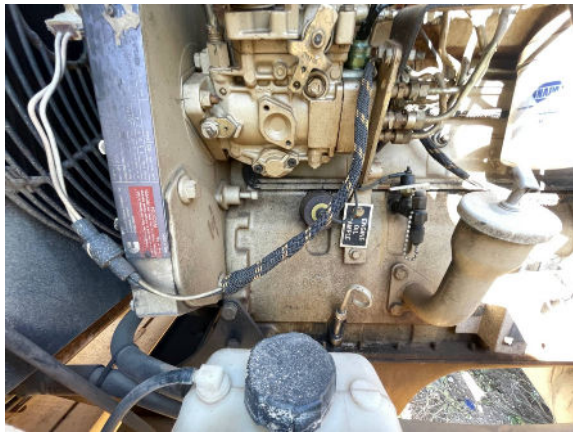
Oil Leaks

YES

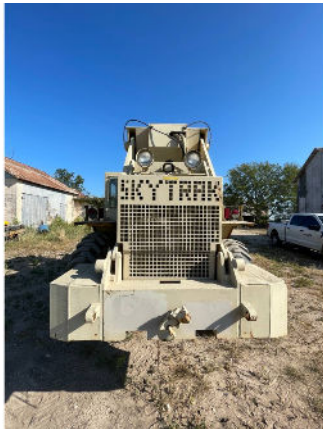
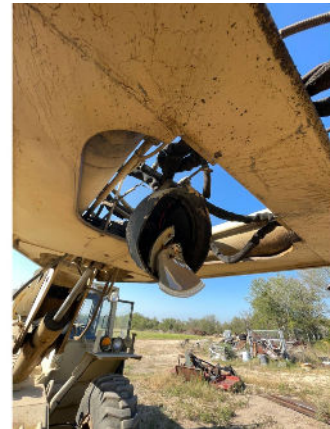
Lighting

numerous lights do not work.
carriage light broken

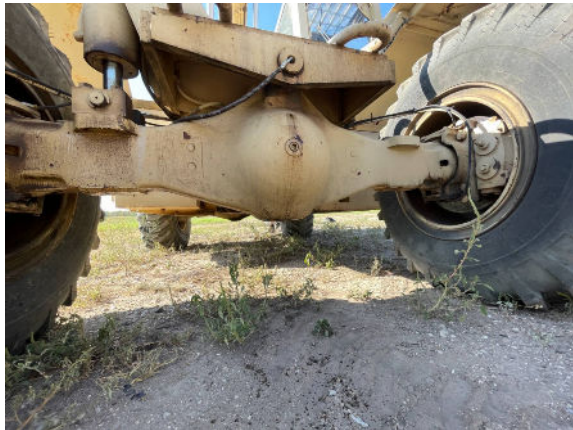
Front Axle

front axle is leaking

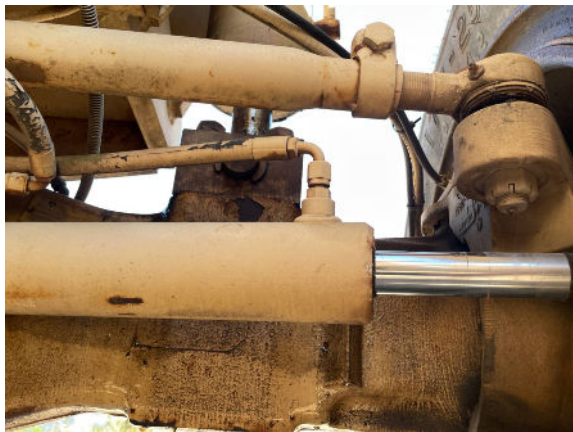
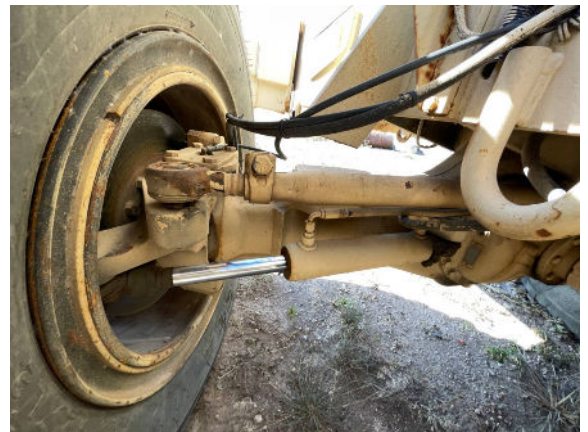
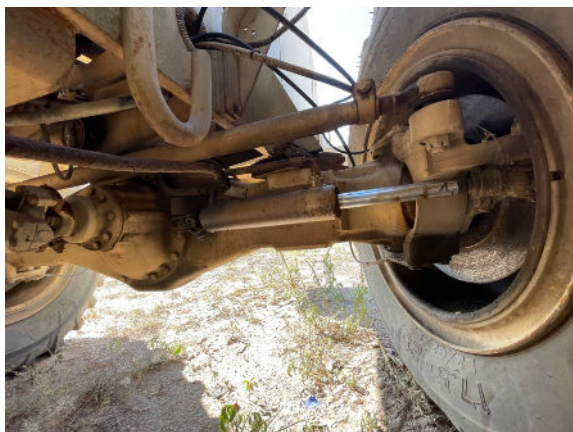
Steering Cylinder

steering cylinders leaking.

●
leaking

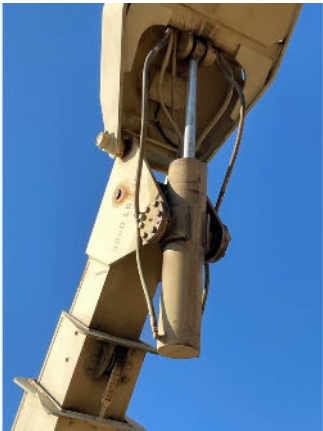
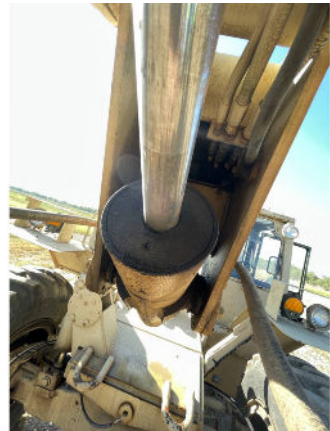
Carriage Cylinder

not able to extend and retract boom sections due to hoses leaking internal of boom. carriage is stuck in outer position and will not function. machine possibly has a control valve issue. hoses will also need to be replaced internal of boom.

leaking

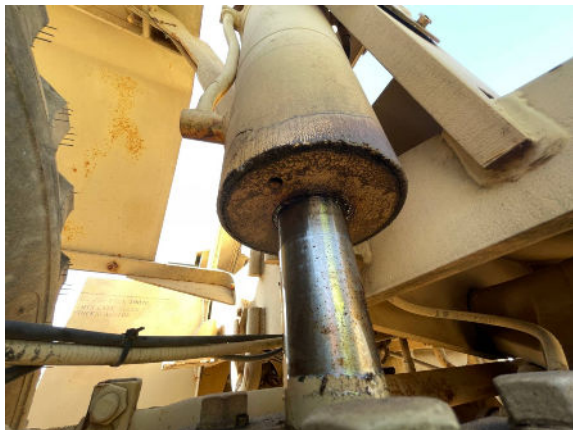
Frame Cylinder

leaking

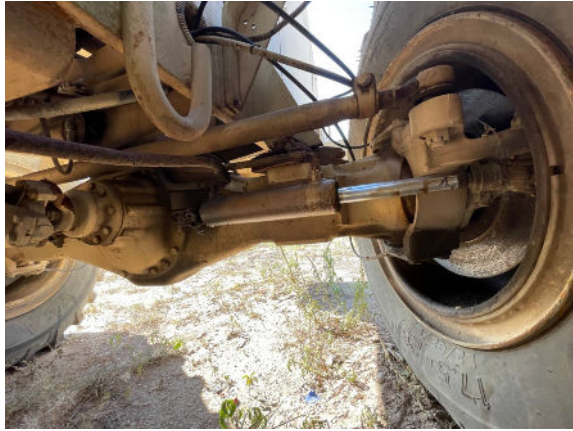
comment 4

front axle is leaking
