1991 SKY TRAK 6000M TELEHANDLER

INSPECTION DETAILS

Inspection Type	[REDACTED]
Inspection Form	Standard
Inspection #	10143674
Inspection Status	Inspected
Created	08/22/24 14:43:04
Updated	08/23/24 07:00:00
Created By	[REDACTED]
Inspector	[REDACTED]
Salesperson	[REDACTED]
Serial #	M1A0660
SMU / Hours	2,016
Location	Rio Medina , TX, United States

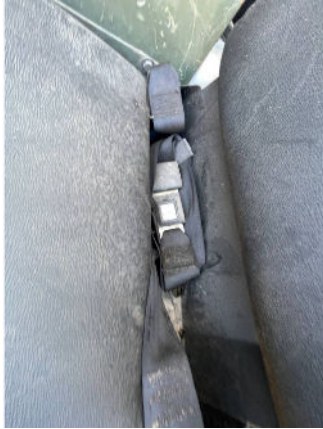
Seat Belt

out of date

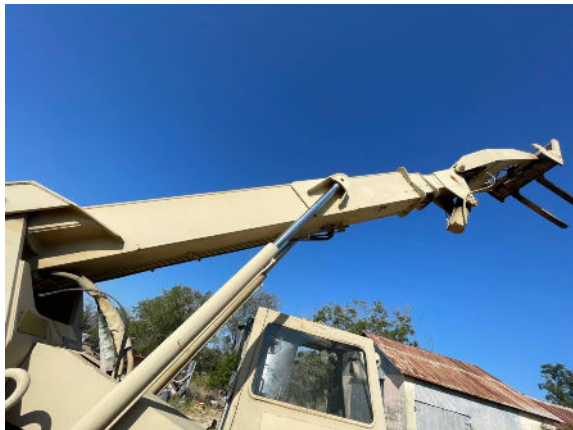
Boom Condition

not able to extend and retract boom sections due to hoses leaking internal of boom. carriage is stuck in outer position and will not function. machine possibly has a control valve issue. hoses will also need to be replaced internal of boom.

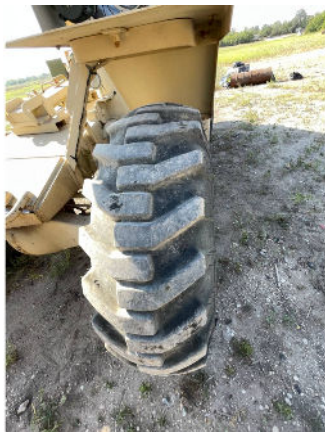
Make / Serial#	Tread Depth in 1/32"	% Life Remaining	Recapped	Tread Cuts/Chunks	Side Cuts Section
Left Front	american contractors	27/32	84%	NO	YES	NO

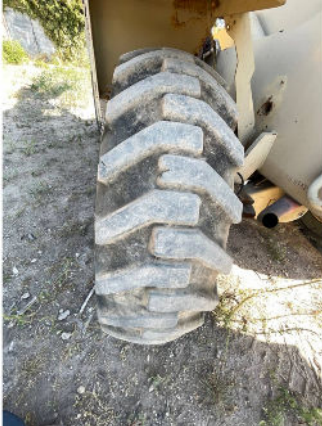
Make / Serial#	Tread Depth in 1/32"	% Life Remaining	Recapped	Tread Cuts/Chunks	Side Cuts Section
Left Rear	american contractors.	29/32	90%	NO	YES	NO

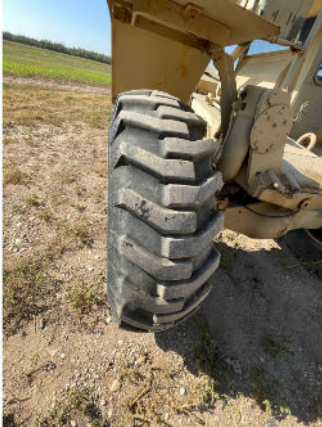
Make / Serial#	Tread Depth in 1/32"	% Life Remaining	Recapped	Tread Cuts/Chunks	Side Cuts Section
Right Front	american contractors	29/32	90%	NO	YES	NO

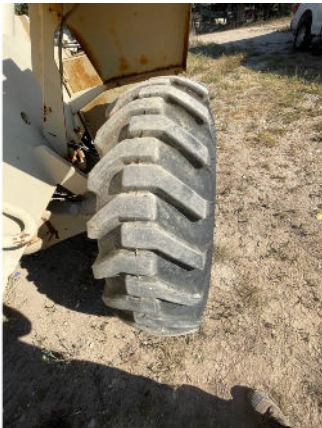
Make / Serial#	Tread Depth in 1/32"	% Life Remaining	Recapped	Tread Cuts/Chunks	Side Cuts Section
Right Rear	american contractors	27/32	84%	NO	YES	NO
